# Problem Analysis of Fabricated Monocrystalline Silicon Solar Cell in Bangladesh

## ABSTRACT

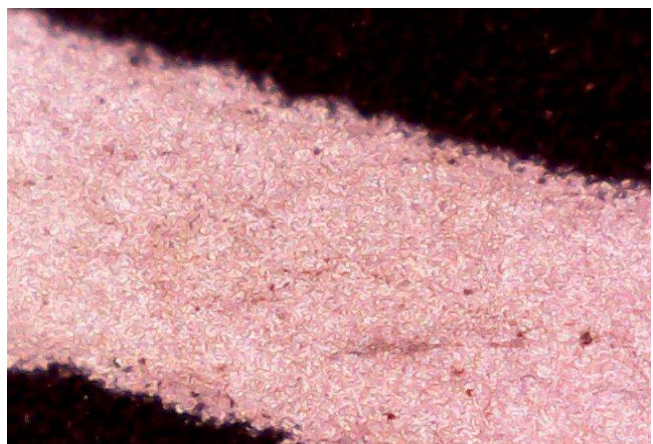
Figures 6 and 7 show that busbars and grid fingers are uniform and straightforward. Magnifying more, comparing busbars between an International standard solar cell and an Indian solar cell (Tata BP Solar Ltd.[19]) it is seen that the silver paste are less dispersed and more straight in the International Standard Solar Cell than the Indian Cell. The busbar of International Standard Solar Cell and Indian Cell are shown in the Figure 8 and Figure 9 respectively.

Fig. 8: Busbar of International Standard Cell

**Fig. 9:** Busbar of Indian Cell

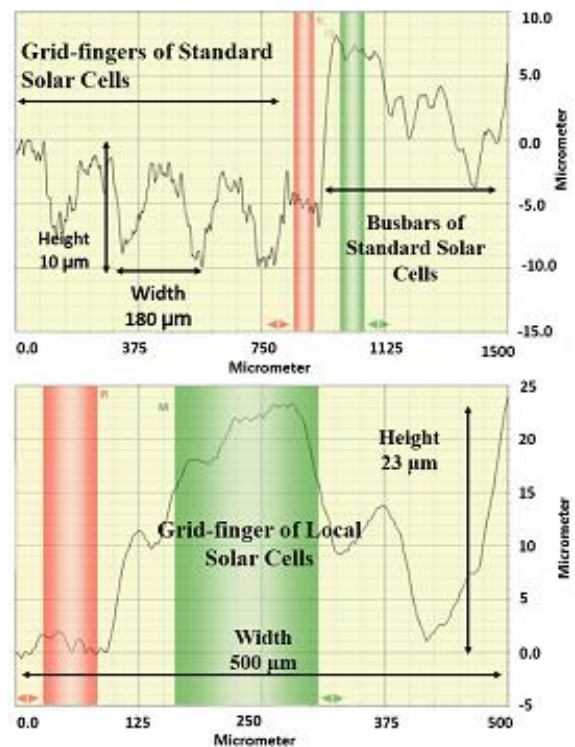
**Fig. 13:** Grid-fingers of standard and local solar cells showing height, width and uniformity

Surface profilometer or surface profiling system is an instrument used to measure the roughness of a surface [20]. In a surface profiling system a stylus run along the sample surface and the up-and-down movements of the stylus are measured. Here a Dektak 150 Surface Profiling System has been used to measure the grid- fingers surface height uniformity. In the upper part of Figure 13 shows Dektak 150 data of the standard solar cell grid-fingers, whereas the lower part of the Figure 13 shows the grid-fingers of the locally made solar cell. Also, the X-axis and Y-axis represents the distance and height in micrometers in the Figure 13. From Figure 13, it is seen that the standard solar cell grid-fingers are a lot thinner in width than locally made solar cell. Measurement shows the maximum height of the standard solar cell grid-fingers are 10  $\mu\text{m}$ .

Moreover, the width of grid-fingers are 180 micrometer and aspect ratio which is defined as the height to width ratio (shown in Figure 14) is 0.0556 for the standard solar cell. On the other hand, again from Figure 13 it is seen that maximum height of the grid-fingers are 23  $\mu\text{m}$ , width is 500  $\mu\text{m}$  and aspect ratio is 0.046  $\mu\text{m}$  for locally made solar cell.

High aspect ratio is required for better efficiency [21], although from the obtained data, it is clearly seen that locally made solar cell aspect ratio is little bit lower than the standard solar cell.

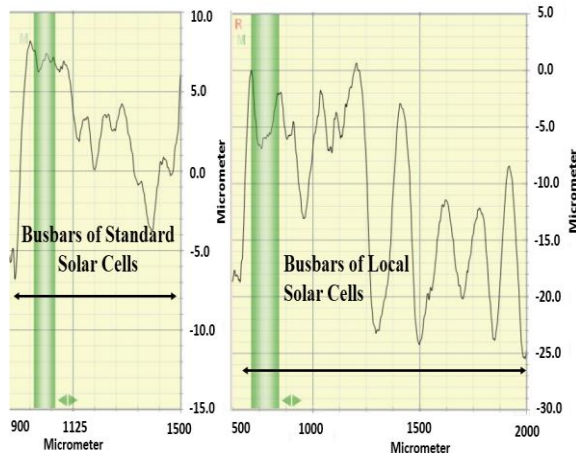
**Fig. 15:** Busbars of standard and local solar cells showing height, width and uniformity

Busbars of both locally made and standard solar cells surface has been analyzed to determine the surface uniformity. It is seen that more hills and valleys exists in locally made solar cell, maximum 23  $\mu\text{m}$  variation is observed whereas 8  $\mu\text{m}$  variation is observed in the standard solar cell as shown in Figure 15.

It confirms the lacking and degeneration of silver paste in busbars observed using optical microscope analysis as shown in the Figure 10.
